1. REPORT NUMBER	2. GOVERNMENT AGENCY	3. RECIPIENT'S CATALOG NUMBER
AD-A086180		8
4. TITLE (and Subtitle) Phase I Inspection Report Lake Adirondack Dam Upper Hudson River Basin, Hamilton County, NY Inventory No. NY 621		5. TYPE OF REPORT & PERIOD COVERED Phase I Inspection Report National Dam Safety Program

UPPER HUDSON RIVER BASIN

LAKE ADIRONDACK DAM

INVENTORY NO. N.Y. 621

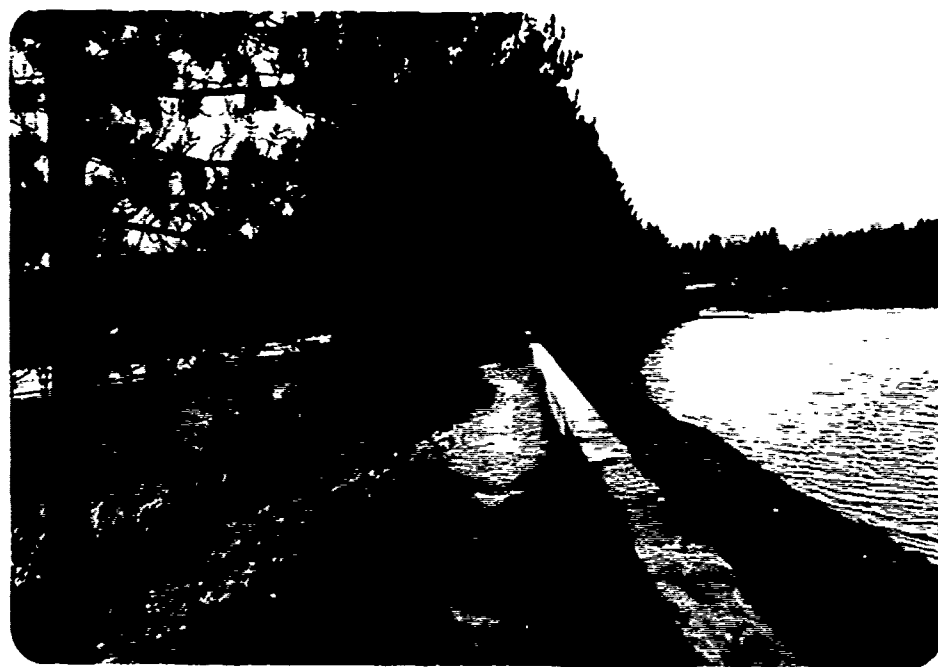
Concrete Wall on Eastern End of Dam - Note Trees on Downstream Slope

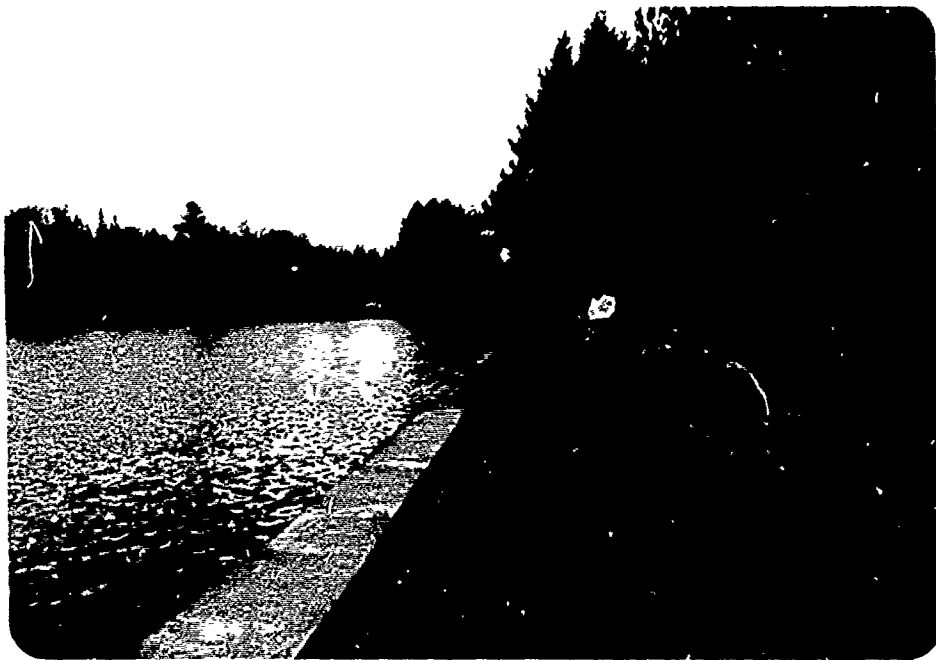
Spillway Looking in Easterly Direction - Note Four Sections on Spillway
